# Comparison

## LFC1 membrane with X-20 membrane

## **Comparison LFC1 with X-20**

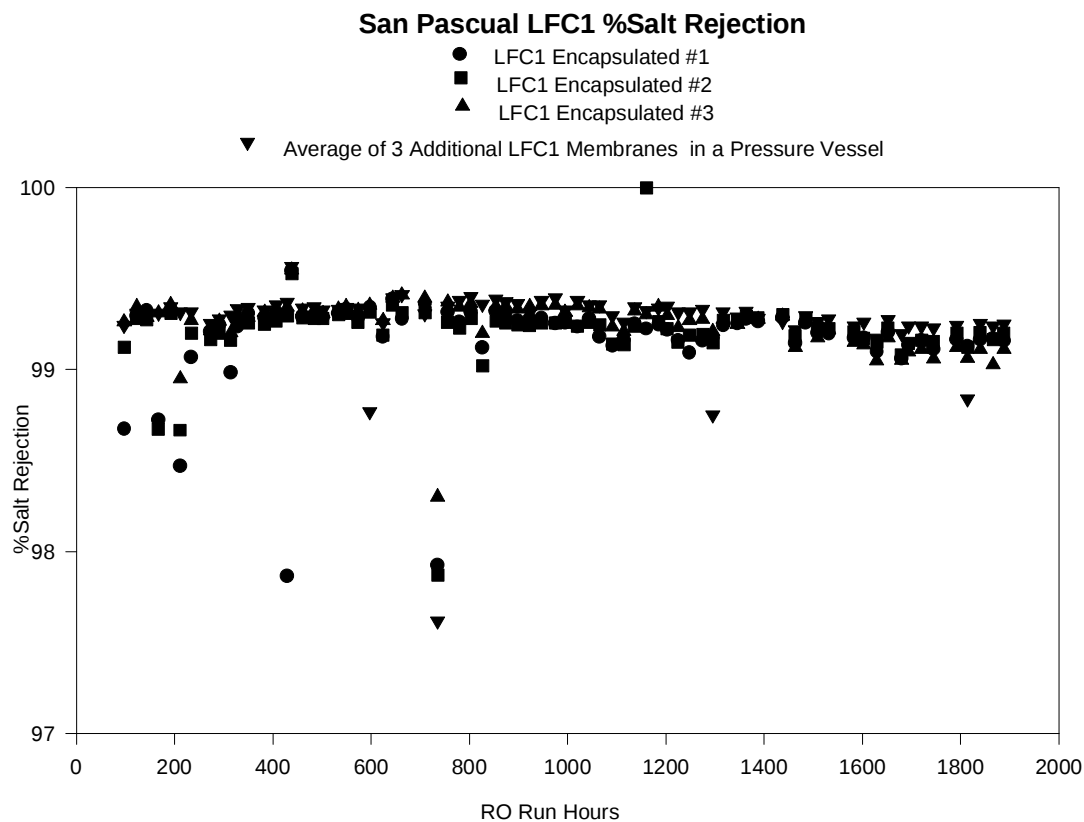
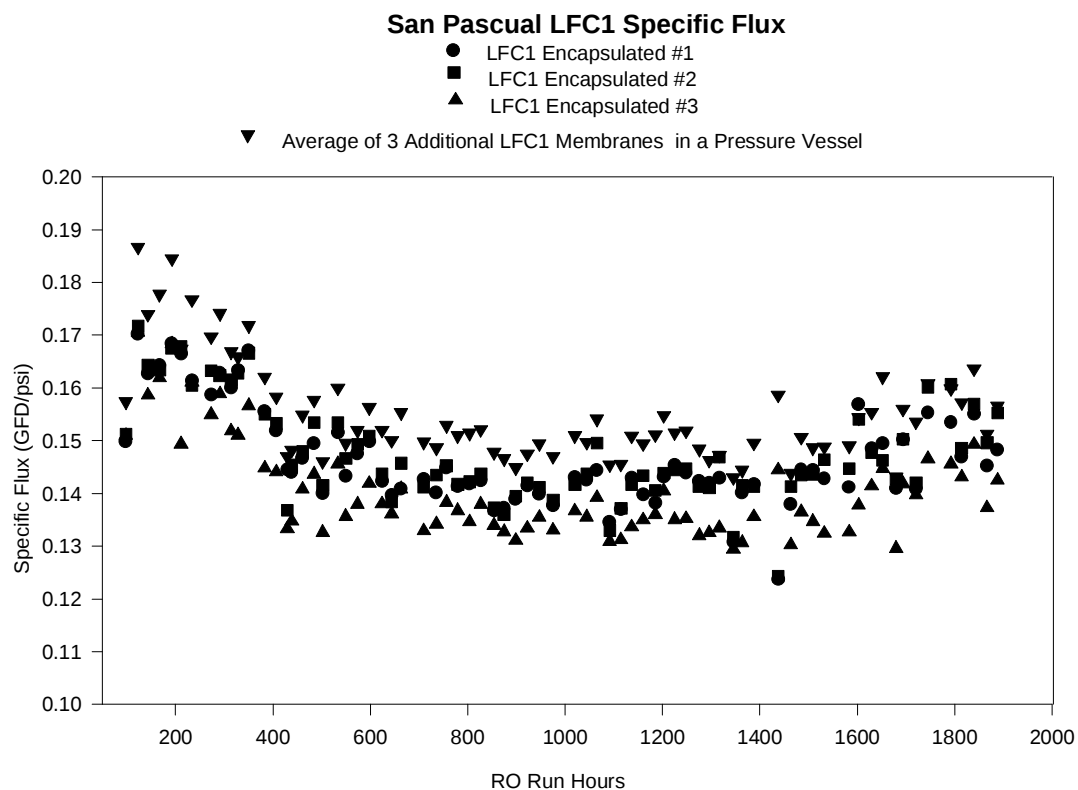
LFC1 membrane is also operating on tertiary municipal effluent at the wastewater treatment plant at San Pasqual, CA. Even on such a heavy fouling feedwater, the performance is very stable as shown in Fig 2 and Fig 3.
